Intel[®] Celeron[®] Processor Specification Update

Release Date: December 2001

Order Number: 243748-039

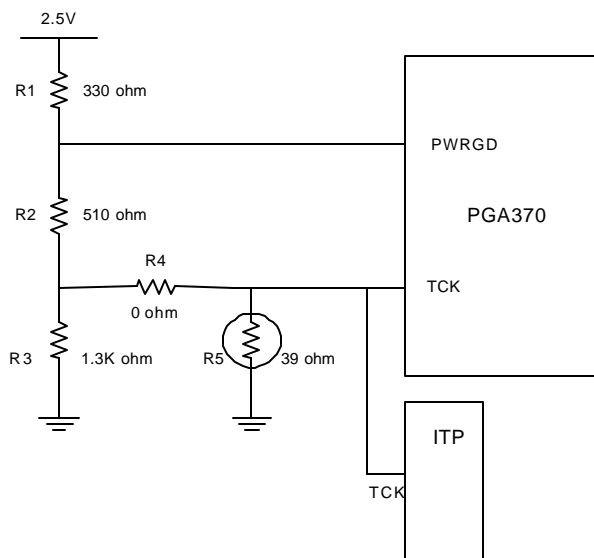
Celeron® on 0.13 micron Processor 256K Platforms Workaround

In addition, the example workaround circuits shown do not support production motherboard test methodologies that require the use of the processor JTAG/TAP port. Alternative workaround solutions must be found if such test capability is required.

For Production Boards:
Depopulate R5

To use ITP:
Install R5, Depopulate R4
